CSMP – Field Advisory Notice (FAN)

SAFE Sens TrakPod Electro Magnetic Interference (EMI)

050218POD0014

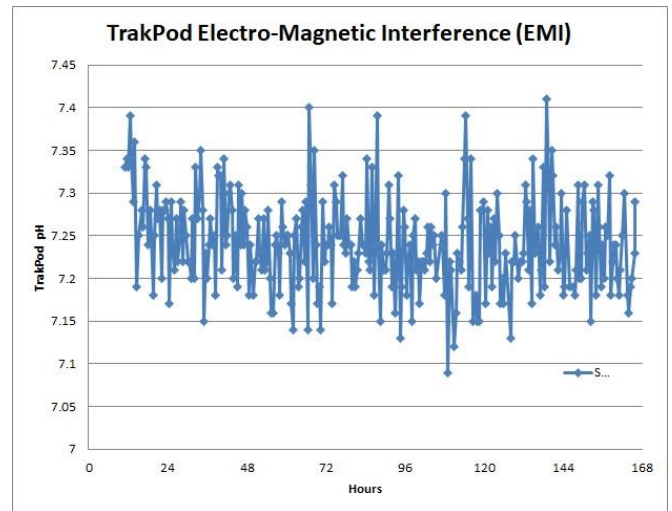
The pH monitoring data from the affected customer sites showed the TrakPod’s fluorescent signals varying from reading to reading, in some case by significant counts. The behavior appeared situational, seemed specific to the TrakPod when placed in a certain condition, and could not always be replicated upon examination. Further investigation found that sufficiently-powerful localized Electro-Magnetic Interference (EMI) may influence the behavior of the current TrakPod design. EMI causes variability in TrakPod measurements, manifesting as noisy pH data. See Figure 1.

Figure 1: TrakPod Electro-Magnetic Interference (EMI) - Example

Service Plan instructions and materials for impacted users are provided by BCSI. Please contact our support team at support@safesens.com for more information on servicing this issue.
