Blood Cell Storage, Inc. (BCSI)  
123 NW 36<sup>th</sup> St.  
Suite 220  
Seattle, WA 98107

## CSMP – Field Advisory Notice (FAN)

Windows build 500 Internal Server Error

150120TAB0019

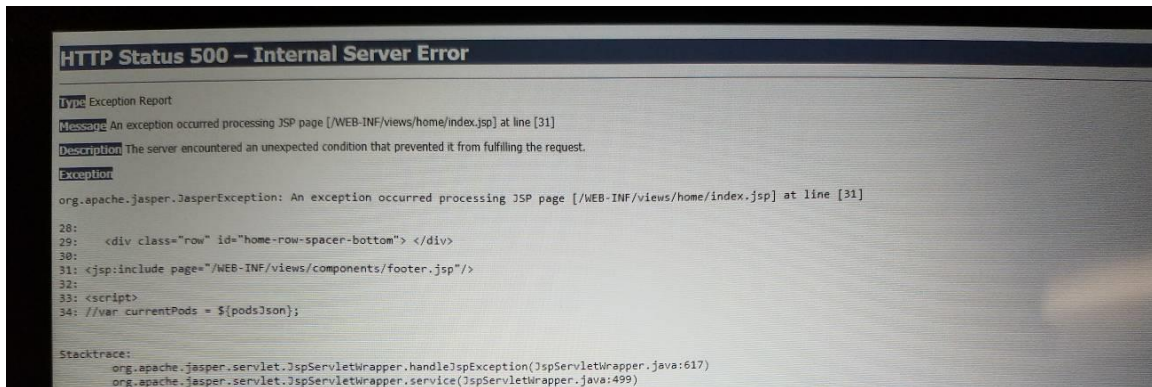
On TrakStation boot, a 500 status error code is displayed instead of the TrakStation software. This is caused due to an error in the TrakStation’s hard drive but can be easily fixed through Windows’ drive repair upon restart.

A simple procedure is followed to scan and fix the drive using Windows:

1. Attach the Keyboard to the tablet if not already connected.
2. Press the Windows key

- 3. Select the Power button icon and then select Restart as below

- 4. Upon restarting, Windows will scan and fix the C: drive. Upon completion, the tablet will boot into Windows and the TrakStation software should load correctly.
