CSMP – Field Advisory Notice (FAN)

sv² sensor & tight fixture fit

070622SV20028

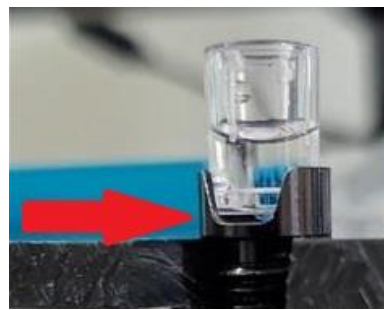
Figure 2: Elevated sv² sensor

If a mild degree of tightness is observed, then the sv² sensor may simply need a push of the finger during placement to seat properly. If the fit is overly tight and placing the sv² sensors is difficult, then the components may need to be serviced in the field. Please contact support@safesens.com to report tight fixture issues and discuss service options.
